# Clinical Case Reports

Before & After Treatment with Curodont™ Repair Fluoride Plus

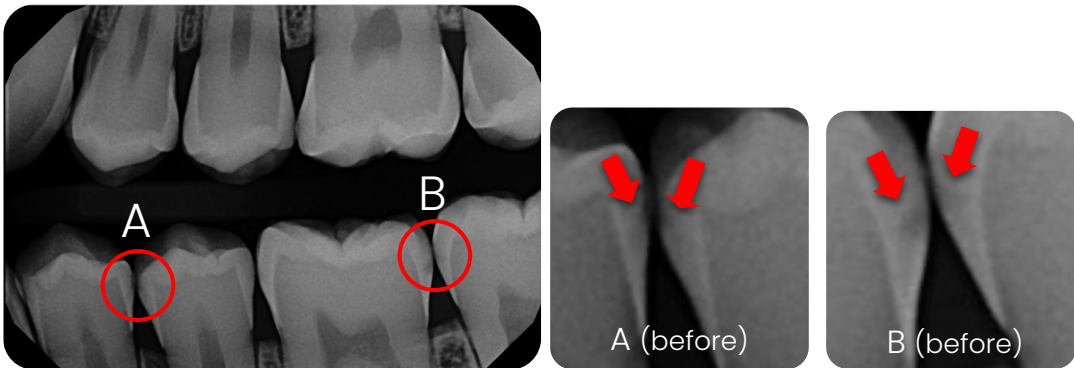
**Figure 1: Before:** Multiple interproximal carious lesions in enamel diagnosed (2.20.2023); lesions put on watch. CRFP applied after 6 months on 8.9.2023.

**Patient Presentation and examination:** In a 14-year-old male patient, on routine bitewing radiographs taken after the completion of orthodontic treatment, multiple radiolucencies were observed in the enamel of the interproximal surfaces of #18 (mesial), #19 (distal), #20 (mesial), and #21 (distal), suggestive of initial caries. (Figure 1)

- #18 (mesial): Initial caries extending to the inner half of enamel (E2)
- #19 (distal): Initial caries extending to the inner half of enamel (E2)
- #20 (mesial): Initial caries extending to the outer half of enamel (E1)
- #21 (distal): Initial caries extending to the outer half of enamel (E1)

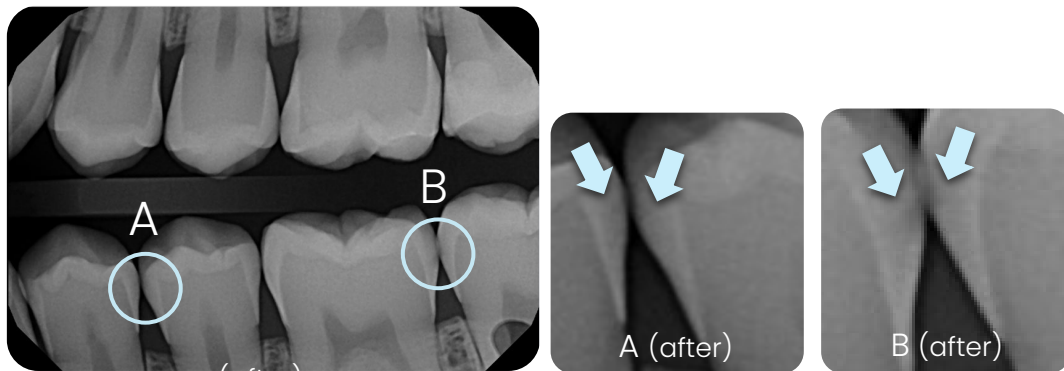
**Figure 2: After:** 6 months post-treatment with CRFP (2.22.2024), the bitewing x-ray revealed regression of the lesions

**Follow-up:** At the 6-month follow-up, regression of the lesions on #18 and #19 to E1 and those on #20 and #21 to E0 was observed, evident on a bitewing x-ray (Figure 2)

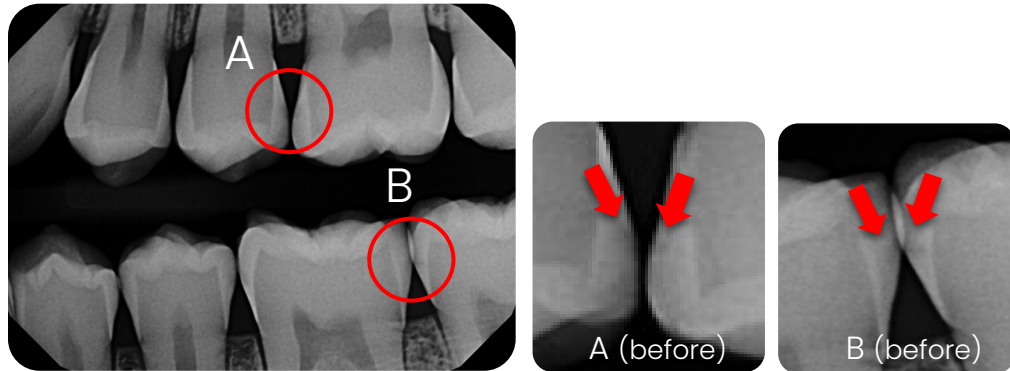
**Figure 1: Before:** Multiple interproximal carious lesions in enamel diagnosed (2.20.2023); lesions put on watch. CRFP applied after 6 months on 8.9.23.

**Patient Presentation and examination:** In a 14-year-old male patient, on routine bitewing x-rays taken after the completion of orthodontic treatment, multiple radiolucencies were observed in the enamel of the interproximal surfaces of #13 (distal), #14 (mesial), #18 (mesial), and #19 (distal), suggestive of initial caries. (Figure 1)

- #13 (distal): Initial caries extending to the outer half of enamel (E1)
- #14 (mesial): Initial caries extending to the outer half of enamel (E1)
- #18 (mesial): Initial caries extending to the inner half of enamel (E2)
- #19 (distal): Initial caries extending to the outer half of enamel (E1)

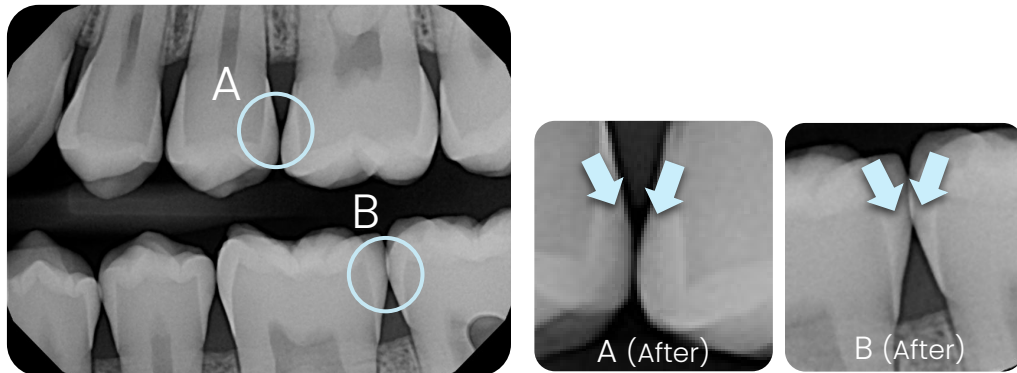
**Figure 2: After:** 6 months post-treatment with CRFP (2.22.2024), the bitewing x-ray revealed regression of the lesions

**Follow-up:** At the 6-month follow-up, regression of the lesions on #13, #14 and #19 to E0 and that of the lesion on #18 to E1 was observed, evident on a bitewing x-ray (Figure 2)

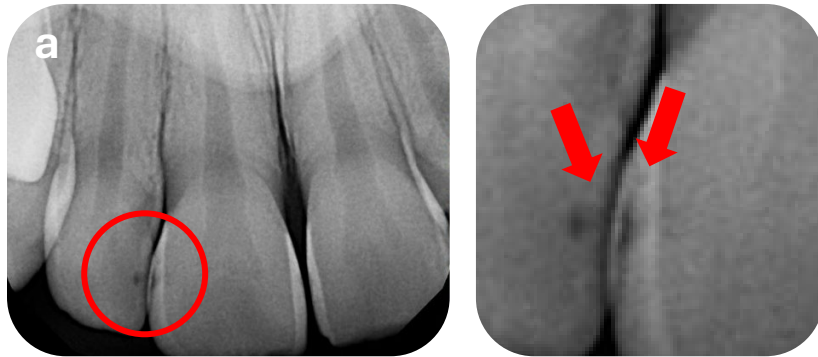
Figure 1: Before: Radiolucencies suggestive of initial caries observed on #7 (D1) and #8 (E2).

**Diagnosis:** Based on the radiographic findings, initial caries extending to the outer third of dentin (D1) on #7 and to the inner half of enamel (E2) on #8 were diagnosed. (Figure 1)

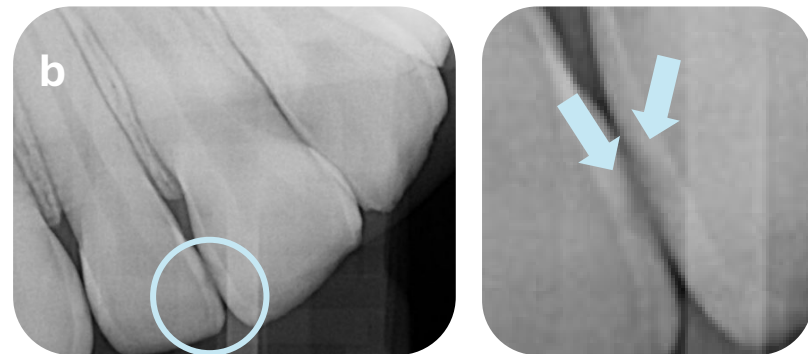
Figure 2: After: 19-month follow-up post treatment with CRFP revealed regression and reduced radiolucency of the lesions.

**Follow up:** The 19-month follow-up x-ray revealed regression of the lesion on #7 to E2, arrest of the lesion on #8, and reduction in the radiolucencies of both lesions. (Figure 2)

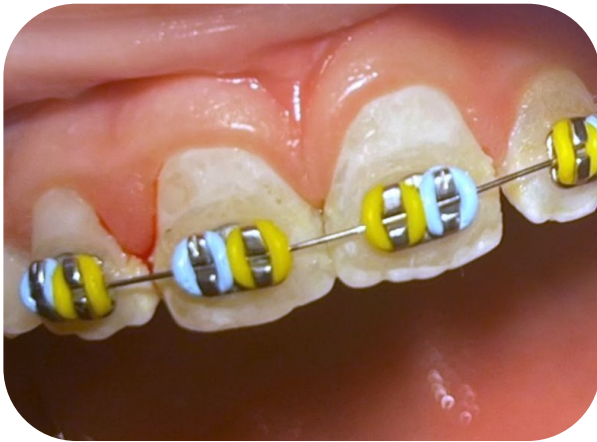
**Figure 1: Before:** White spot lesions seen around bonded brackets on #7, #8, #9, and #10 (7.5.2023)

**Diagnosis:** Initial carious lesions, seen as white spot lesions, were diagnosed on the labial surfaces of #7, #8, #9, and #10. (Figure 1)

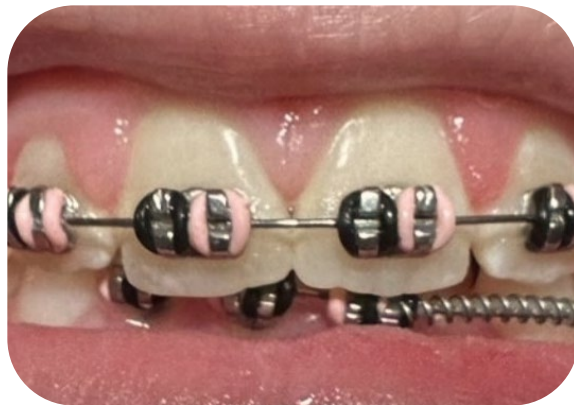
**Figure 2: After:** 5 months post CRFP, a visible reduction in size and appearance of the white spot Lesions observed (12.13.2023)

**Follow-up:** After 5 months, the white spot lesions appeared reduced. The central incisors demonstrated almost total regression of the lesions. (Figure 2)

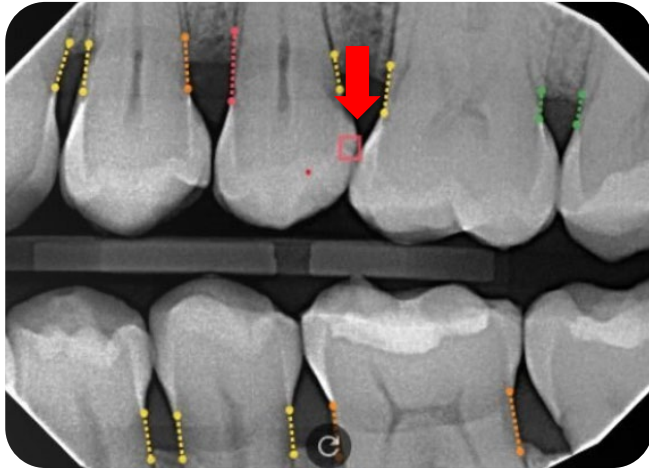
Figure 1: Before: Proximal lesion (E2) on distal surface of #13.

**Diagnosis:** Based on the radiograph, initial caries extending to the inner half of enamel (E2) on the distal surface of #13 was diagnosed. (Figure 1)

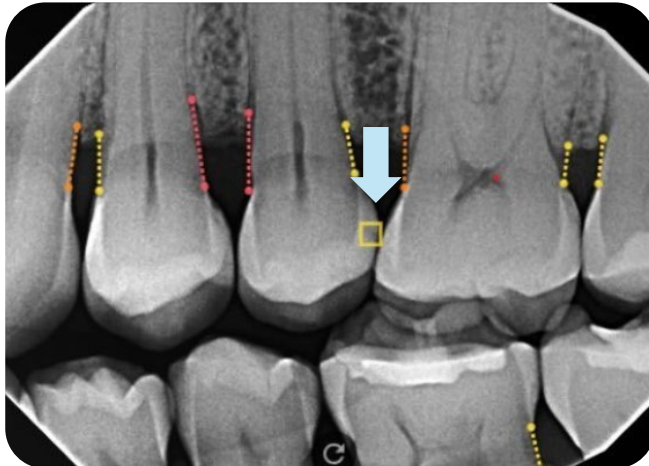
Figure 2: After: At the 4-month follow-up post CRFP, regression of the lesion to E1 was observed, confirmed with AI.

**Follow-up:** The 4-month follow-up revealed regression of the lesion to the outer half of enamel (E1), which was confirmed by the AI software. (Figure 2)

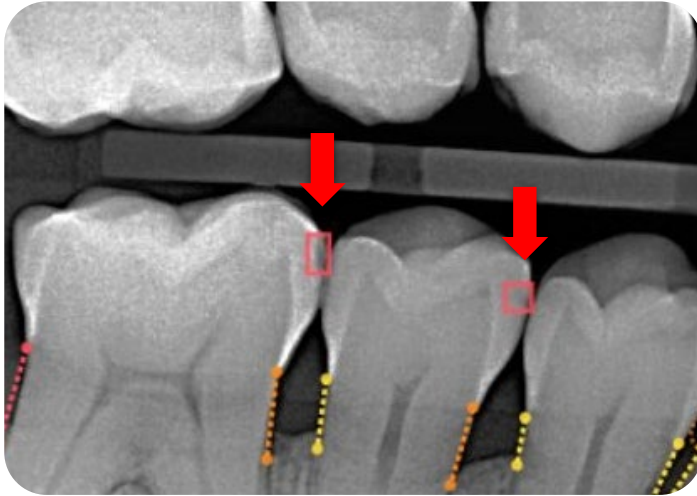
**Figure 1: Before:** Proximal lesions detected with bitewing radiographs on mesial surfaces of #29 & #30.

**Diagnosis:** Based on the radiograph, initial caries extending to the outer half of enamel (E1) on the mesial surfaces of #29 and #30 were diagnosed. (Figure 1)

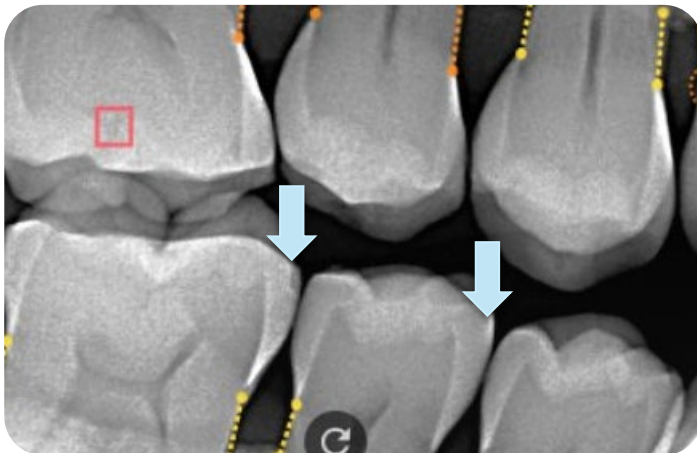
**Figure 2: After:** At the 4 month follow up post CRFP, the AI did not detect the area as caries.

**Follow-up:** The 4-month follow-up revealed regression of the lesions, indicated by an absence of radiolucency, and the confirmation of the same with AI. (Figure 2)

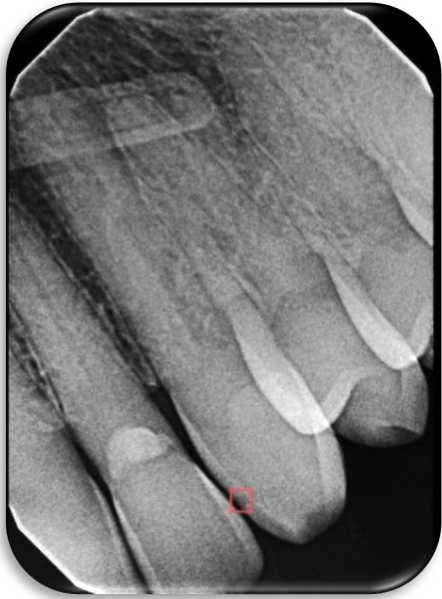
**Figure 1:** Before: Proximal lesion detected on the mesial surface of #11

**Diagnosis:** Based on the radiograph, initial caries extending to the inner half of enamel (E2) on the mesial surface of #11 was diagnosed. (Figure 1)

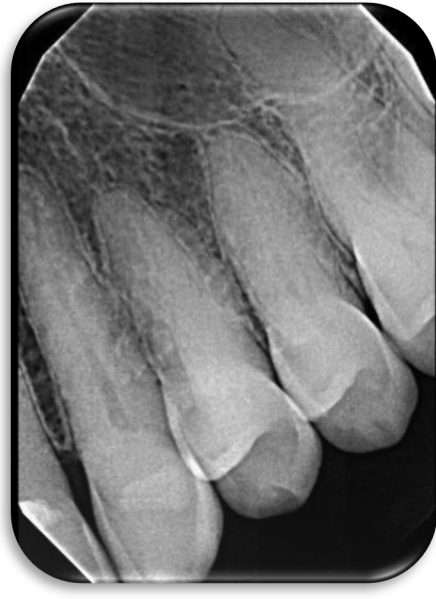
**Figure 2:** After: At the 4 month follow up post CRFP, the AI did not detect the area as caries.

**Follow-up:** The 4-month follow-up revealed regression of the lesion, indicated by an absence of radiolucency, and the confirmation of the same with AI. (Figure 2)

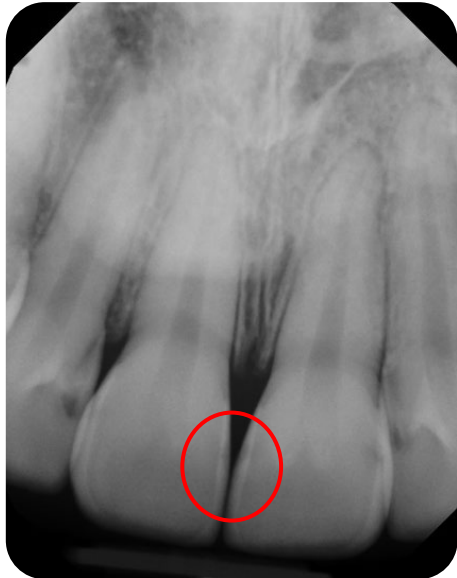
**Figure 1:** Before: Initial caries extending to the inner halves of enamel (E2) on the mesial surfaces of #8 and #9

#8 (mesial), #9 (mesial): initial caries in the inner half of enamel (E2)

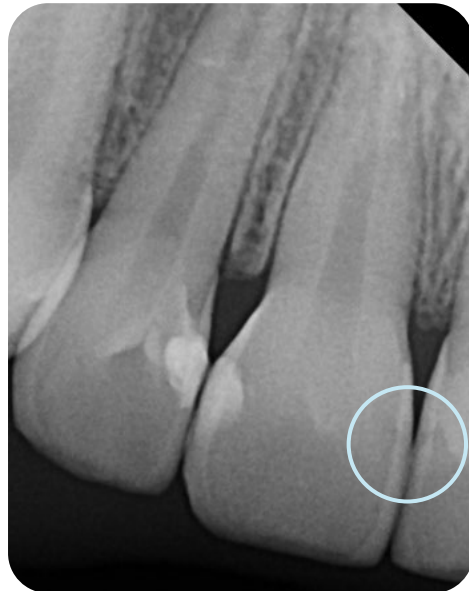
**Figure 2:** After: 3 months post-CRFP, regression of the lesion #8 and stability in that on #9

**Follow up:** On the 3-month follow-up, the lesion on #8-mesial showed regression to the outer half of enamel (E1) and that on #9 stayed stable, indicating arrest of progression.

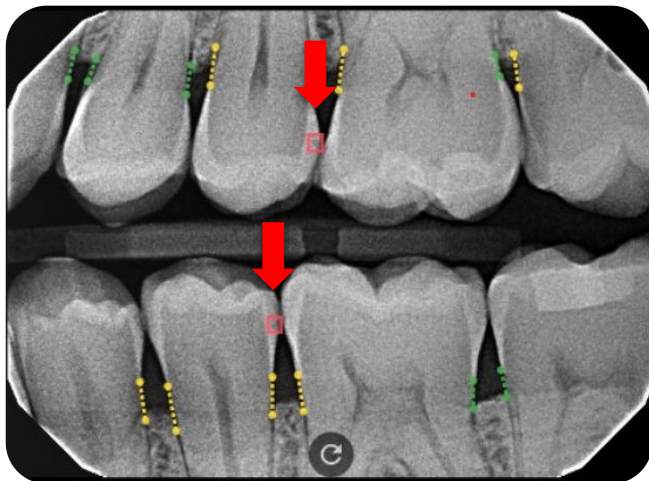
**Figure 1:** Before: Initial carious lesions on #13 (distal) and #20 (distal) extending to the outer half of enamel (E1)

**Diagnosis:** Based on the radiograph, initial caries extending to the outer half of enamel (E1) on the distal surfaces of #13 and #20 were diagnosed. (Figure 1)

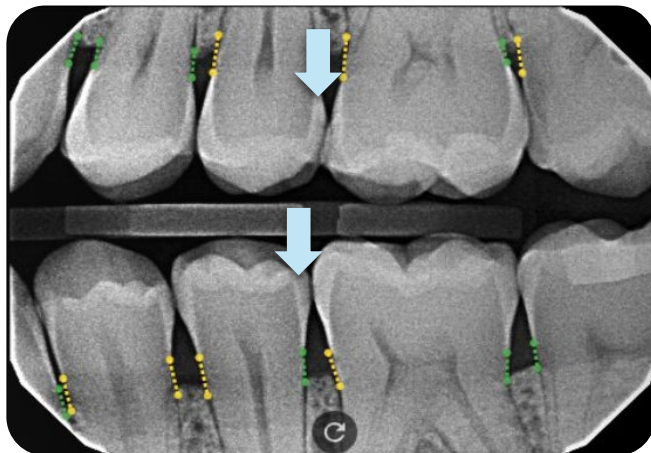
**Figure 2:** After: At the 7 month follow up, regression of the lesions was seen, and confirmed with AI.

**Follow-up:** The 7-month follow-up revealed complete regression of the lesions (E0), which was confirmed by the AI software. (Figure 2)

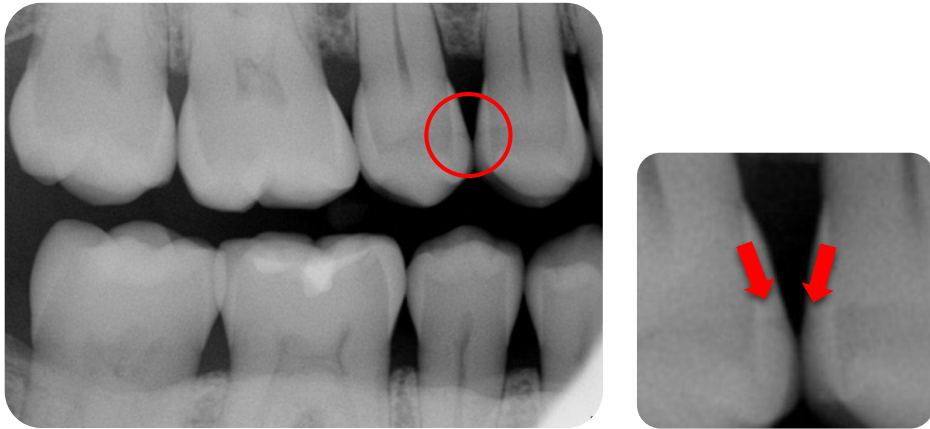
**Figure 1:** Before: Initial carious lesions on #4(mesial) and #5(distal) extending to the outer half of enamel (E1)

**Diagnosis:** Based on the radiographs, initial caries extending to the outer half of enamel (E1) on #4 (mesial) and #5 (distal) were diagnosed. (Figure 1)

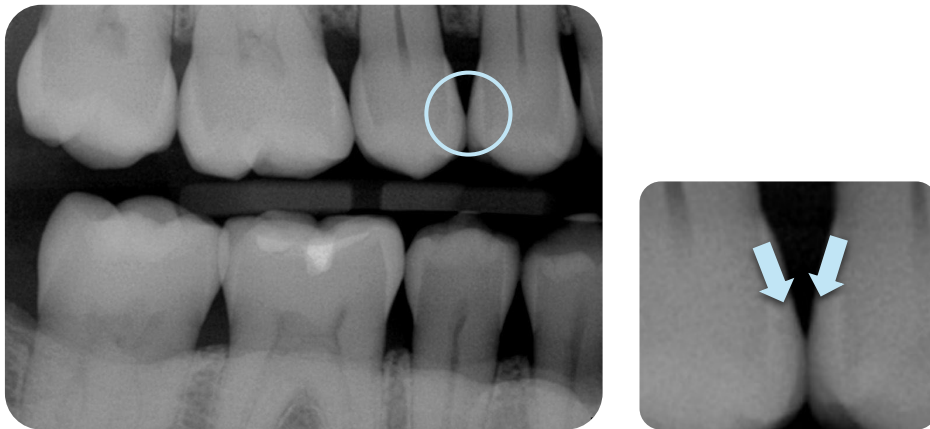
**Figure 2:** After: At the 6 month follow up, reduction in size and radiolucency seen.

**Follow-up:** The 6-month follow-up revealed reduction in the size and radiolucency of both lesions, indicating regression of both lesions. (Figure 2)
